On-Board Measurements At A 100MW High-Head Francis Turbine

M. Titzschkau, V. Hasmatuchi, J. Decaix, C. Münch-Alligné

Abstract: The Francis turbine runners of the four ternary groups of Grimsel 2 power plant in Switzerland showed fatigue cracks at the runner blades much earlier than expected. To find the source of these cracks, strain gauges and accelerometers were used to get information about the harmful stresses on the runner during operation. It is observed that the speed no-load operation during the start-up and the shutdown processes of the turbine impose large stresses on the runner blades.

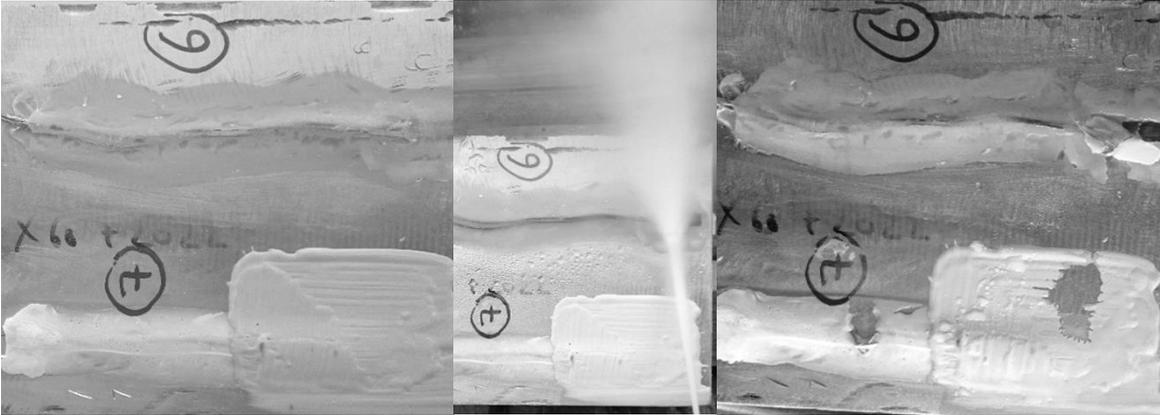
Fig. 1: Glue specimens, testing and results.

the chamber to the runner properly even under harsh operating conditions like pump start-up or the imbalance imposed by the instrumentation inside of the chamber. Moreover, the strain gauge application and protection was tested with over realistic harsh conditions under high pressure flow (Fig. 1) to ensure a minimum risk of losing them during the tests. The strain gauges and the cables were protected with a solid layer of glue that was grinded and polished to reduce as much as possible the influence to the flow. The accelerometers and the tachymeters were mounted directly inside the sealed chamber.

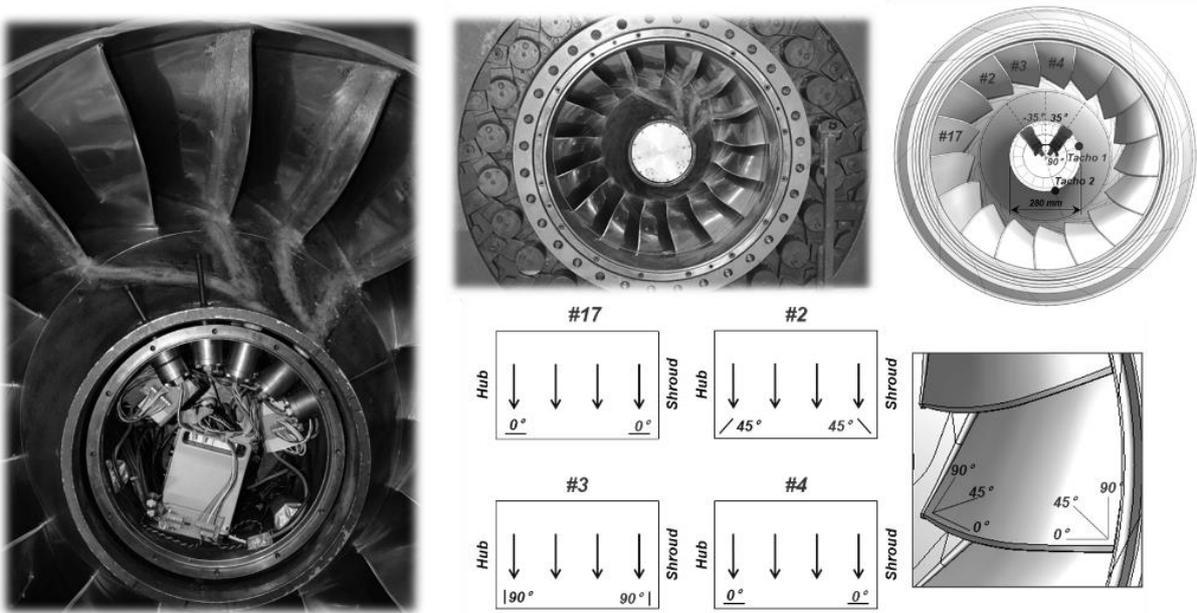
Fig. 2: Instrumentation setup on the runner, Hasmatuchi et al. [8].

The Fig. 2 shows the setup of the different sensors on the runner. The strain gauges were applied at four blades at different angles close to the connection between hub/shroud and blade. During the installation one set of strain gauges at blade 4 got damaged. However, since the same direction of strain was measured at blade 17, this loss was acceptable.

The on-board instrumentation (listed in Table 1) consisted of eight strain gauges fixed on the turbine runner blades, two accelerometers and two tachymeters installed on the runner crown tip. The data acquisition system was mounted in a sealed chamber placed in the centre of the runner and supplied with energy by batteries. Once mounted into the turbine, the access to the system was only for charging and data transfer. Indeed, due to the special construction of the draft tube, there was no direct access to the acquisition system. The acquisition rate of the system was set to 10 kHz and the autonomous working time is of at least 12 hrs.

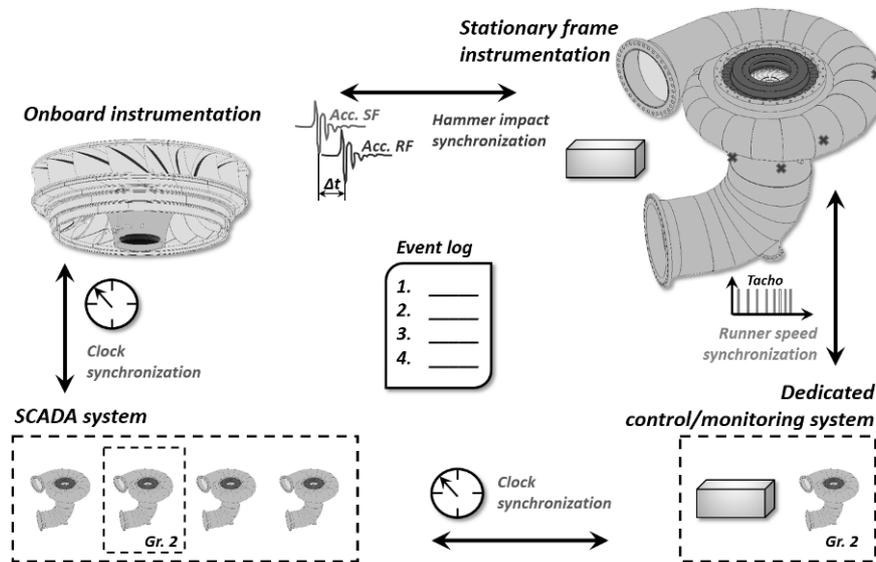
Fig. 3: Synchronization between the different acquisition systems, Hasmatuchi et al. [8].

The method of synchronization in between the different acquisition systems is sketched in Fig. 3. The synchronization between the different systems can be done easily by using several values like guide vane opening, rotational speed or pressure fluctuations that are sampled in both systems. To synchronise the on-board and the

stationary frame systems, hammer impacts on the generator shaft, easily detectable especially by the accelerometers available in both systems, were used.

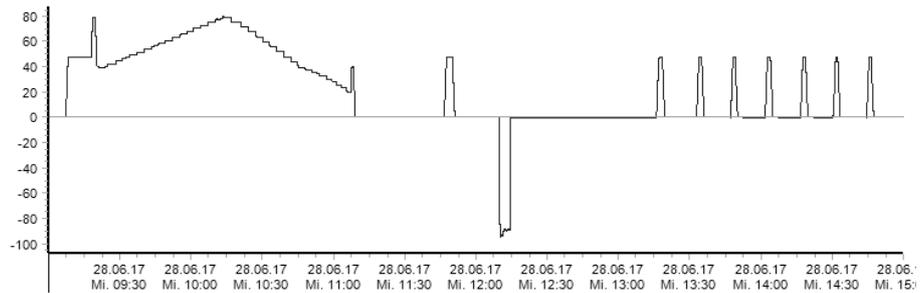
Fig. 4: History of electrical power [MW] during tests.

Fig. 4 shows the history of load cycles during the testing campaign. Negative power means pump operation. Then, the several isolated positive peaks show the machine starts. Finally, the turbine load during the first period of tests includes two part-load to full-load and vice versa cycles performed in dynamic and in static conditions. In between the load tests, the machine was braked down electrically.

The given net head at the time of the tests was in between 368.5 mWC and 374 mWC, depending on the losses in the hydraulic system, and the maximum electrical output P_{max} was 79.31 MW. The other groups were running at steady conditions during the tests so that the hydraulic system was stable.

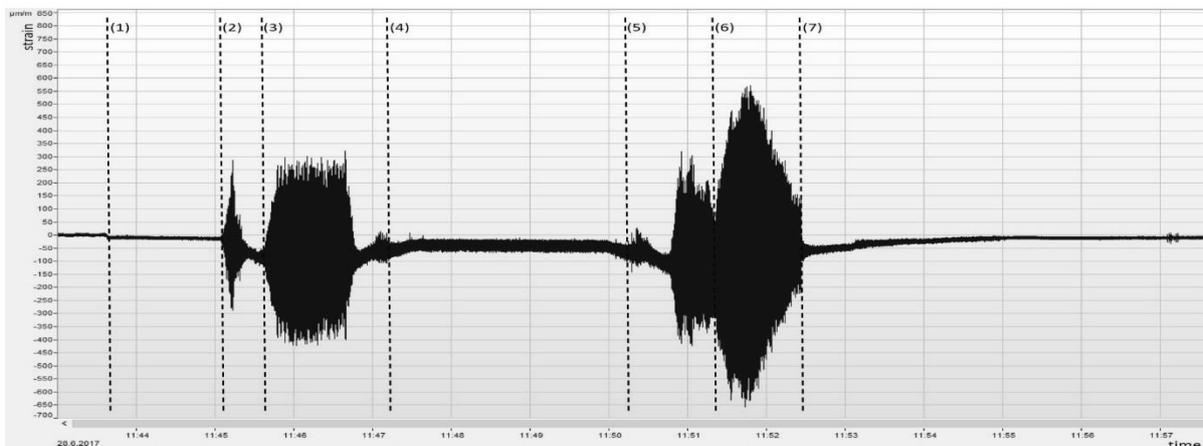
Fig. 5: History of strain fluctuations during one turbine start-to-stop cycle.

The results of the on-board measurements show clearly that there are significant differences in the strain behaviour during a complete cycle from start to standby load (47.5MW) and back to stop (see Fig. 5). On the basis of signal coming recorded from the strain gauge 17, hub, 0°, the load of the runner blades can be clearly separated in the following events:

- filling of the turbine (1)
- initial opening of the guide vanes and getting to nominal speed (2)
- synchronizing of the turbine (3)
- turbine operation (4)
- closing of the guide vanes for shutdown, passing very deep part loads (5)
- turn-off of the generator circuit breaker (6)
- draining of the spiral casing and run out (7)

As expected according to recent published studies, the speed no load (SNL) operation phase (3) imposes high stresses on the runner. Depending on the frequency state of the grid, this process can take up to several minutes or even leads to a shutdown of the machine if the synchronization fails after a certain time. During operation, the stresses are getting smaller compared to the SNL operation. Passing the very deep part load during the shutdown phase creates a stress peak again. However, the most surprising is the fact that turning off the power circuit breaker (6) imposes the highest peaks of strain onto the blades. This could be observed at all strain gauges and happened during all shutdowns of the turbine. Compared to full load or deep part load, this peak is dominant, as shown in Fig. 6 and its amplitude being up to 4.5 times bigger than at full load.

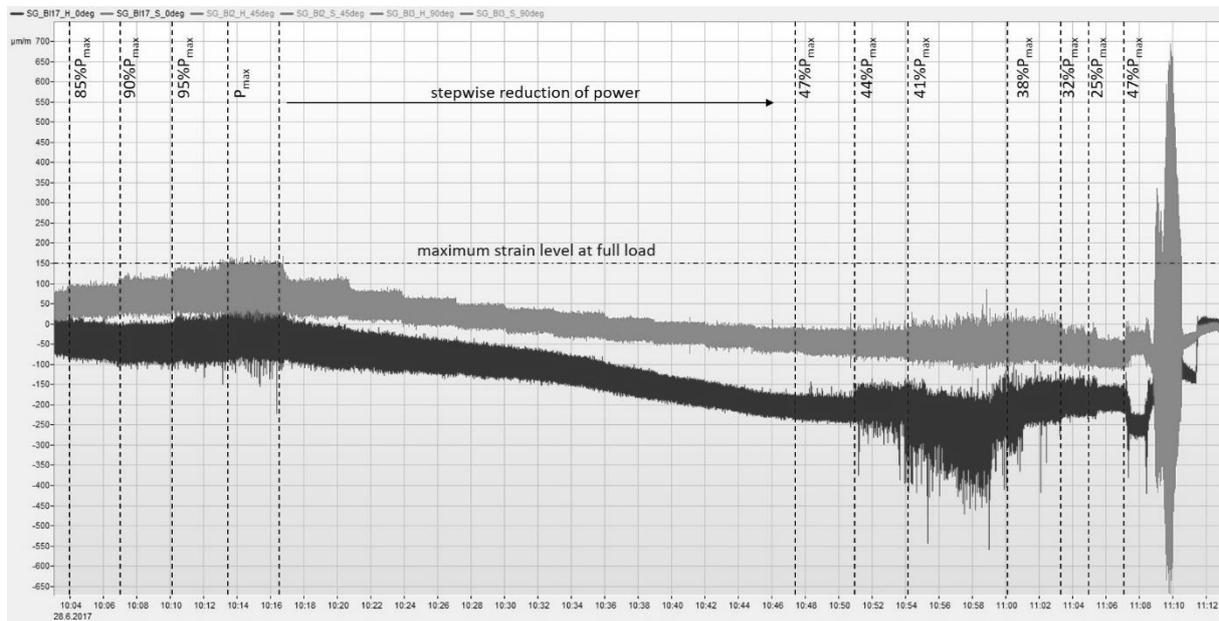
Fig. 6: Strain fluctuations at different loads, blade 17, hub, 0° (dark grey) and shroud, 0° (light grey).

It is also visible in Fig. 6 that there are higher amplitudes in some deep part load operating points in between 41% and 38%, corresponding to the points where the machine appears to be more noisy (cavitation inside the machine being noticed) than at all other loads except start and stop.

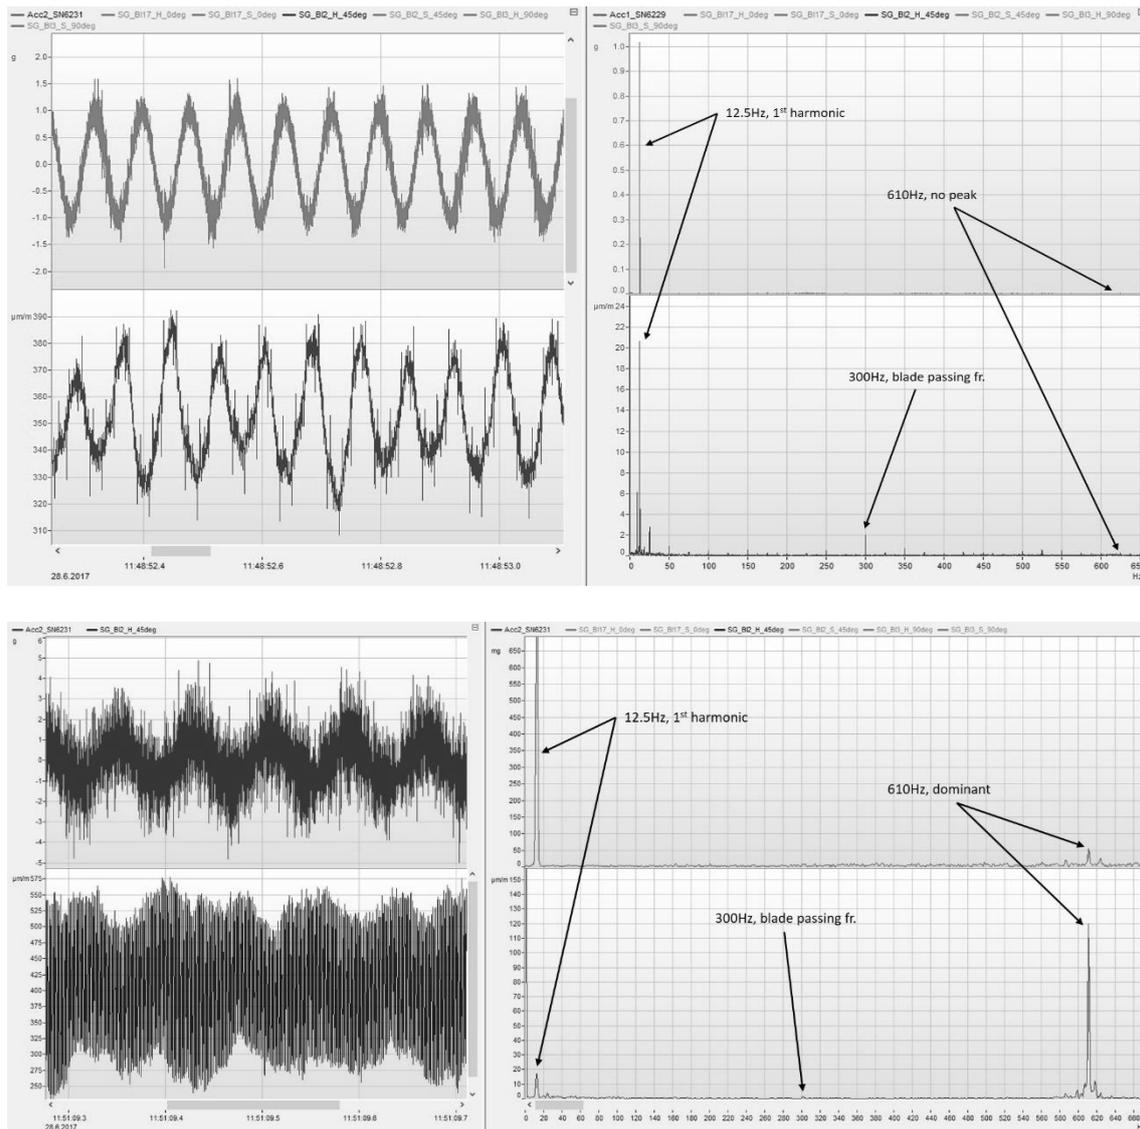
Fig. 7: Dominant frequencies during normal operation (top) and shutdown (bottom).

The following section shows results from the strain gauge at the hub of blade two, 45° direction, in a complete start-stop-cycle. This corresponds to the region where the cracks used to happen. At stable part load operation, a closer look on the graphs in the top side of Fig. 7 reveals at least some speed dependant frequencies and the blade passing frequency. The first harmonic (12.5 Hz) dominates both the vibrations and the strain, whereas the blade passing frequency ($12.5 \times 24 = 300$ Hz) is clearly visible as strain fluctuations. Additionally, a sub harmonic frequency is present during this operating point.

During the synchronization and shutdown phases, the behaviour changes completely and a new dominant peak at 610Hz appears (see the bottom graphs of Fig. 7). Compared to the values of the peaks during part load stable operation, this frequency imposes big additional load to the blade. Fig. 8 shows this effect during very deep part load before the guide vanes close completely. During the synchronization phase, the frequency behaviour looks very similar.

The observed frequency of 611Hz compared to the nominal rotating frequency of 12.5Hz ($f/f_n = 48.9$) is very close to the first harmonic of the blade passing frequency and therefore shows the response of one of the runner Eigen modes (see the results presented by Decaix et al. [9]). Since this clearly dominating frequencies have been also detected by the external microphone, the proximity sensors and the accelerometers on the turbine casing, further non-intrusive measurements can be done by using this results as a foundation.

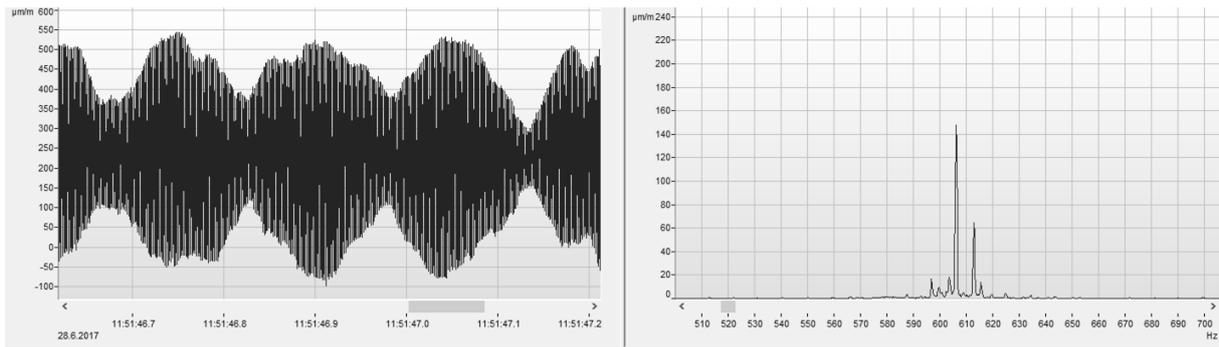
Fig. 8 : Strain fluctuations after the electrical shutdown.

After the circuit breaker is turned off the strain fluctuations show the highest amplitude values. A closer look into the spectre shows two peaks in the region of 611Hz which diminish with decreasing speed. The second peak also adds a significant amount of strain which leads to the high values at this point. The source of this excitation is to be found in the machine control. Once the minimum power is reached the power circuit breaker turns off which influences the speed of the machine. This leads to a reaction of the turbine governor which is trying to keep speed by regulation the guide vanes and consequently keeps the turbine at SNL condition. This takes as long as the next step, shutdown of the erection, is completed (around several seconds). Only then, the guide vanes are closed completely.

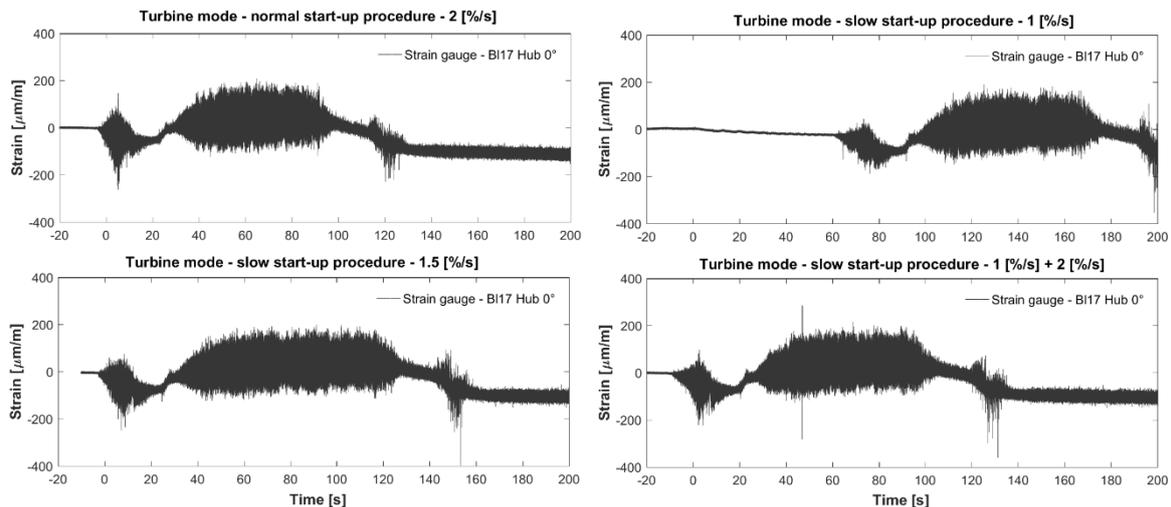
Fig. 9 : Strain fluctuations during normal and modified slower turbine start-ups.

The tested variations in opening speed of the guide vanes to reach nominal speed showed no improvements in the strain behaviour of the machine (see Fig. 9). Moreover, with the broken opening law, a structural excitation frequency in the cavern was triggered, being detected by the vibration monitoring system of the machine, but undetected on the runner blades.
